***Reconnaissance of West Brook and  
Little 5 Mile Creeks  
Fayette County, Texas***

Document No. 140015

MCA Petroleum  
P.O. Box 1287  
San Marcos, Texas 78676

Atkins  
6504 Bridge Point Parkway, Suite 200  
Austin, Texas 78730

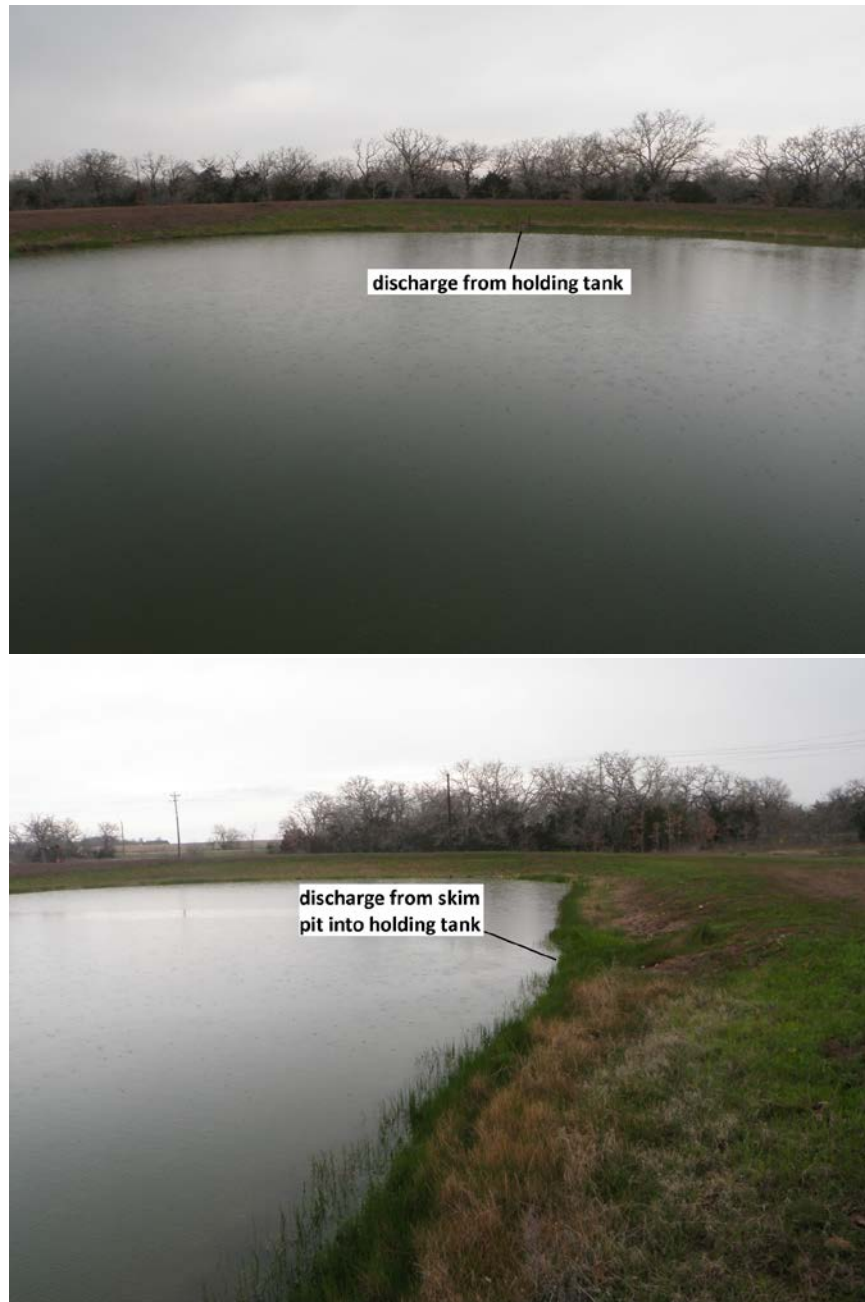
The holding tank is a constructed oval earthen pond (Figure 2). Surface area of the tank was about a quarter of an acre and it is reported to be about 10 feet deep. Discharge from the Southwest Muldoon Field Battery 1 skim pit enters the east side of the tank and exits the west side of the tank from subsurface pipes. The water in the tank appeared clear with an estimated Secchi disk transparency of at least 3 feet.

The shoreline of the tank has a 1- to 2-foot-wide band of spike rush interspersed with *Spirogyra* (filamentous green algae). A kick net sweep of the spike rush revealed damselfly and dragonfly nymphs, and frogs.

Figure 2. Southwest Muldoon Field Battery 1 Holding Tank on March 5, 2014.  
Photo by David Buzan, Atkins, at 16:10 CST. Top photo of west side of tank.  
Bottom photo of east side of tank showing discharge into tank from the skim pits.

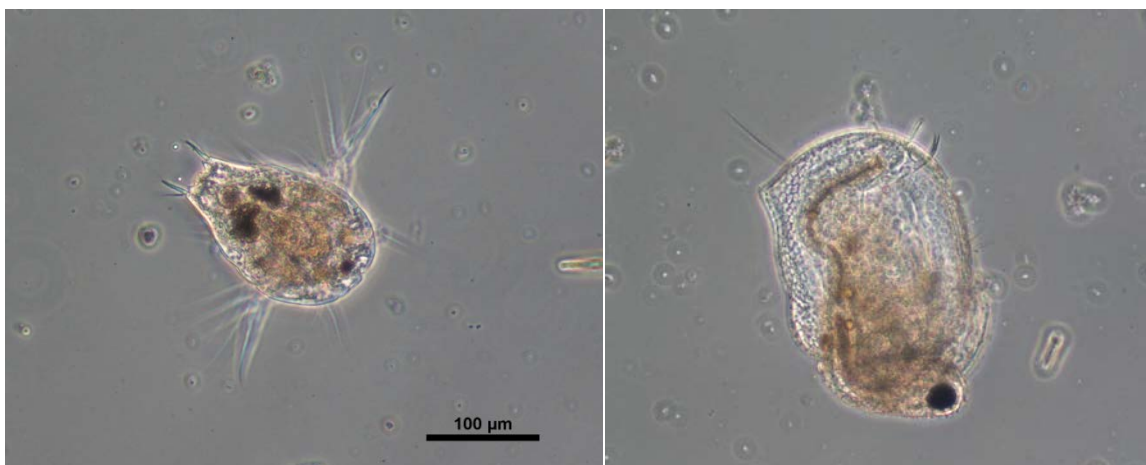
Figure 3. Cyclopoid copepod nauplius on the left and *Ceriodaphnia* on the right from holding tank plankton. Photos by David Buzan.

Other organisms collected in the net plankton included (Figure 3):

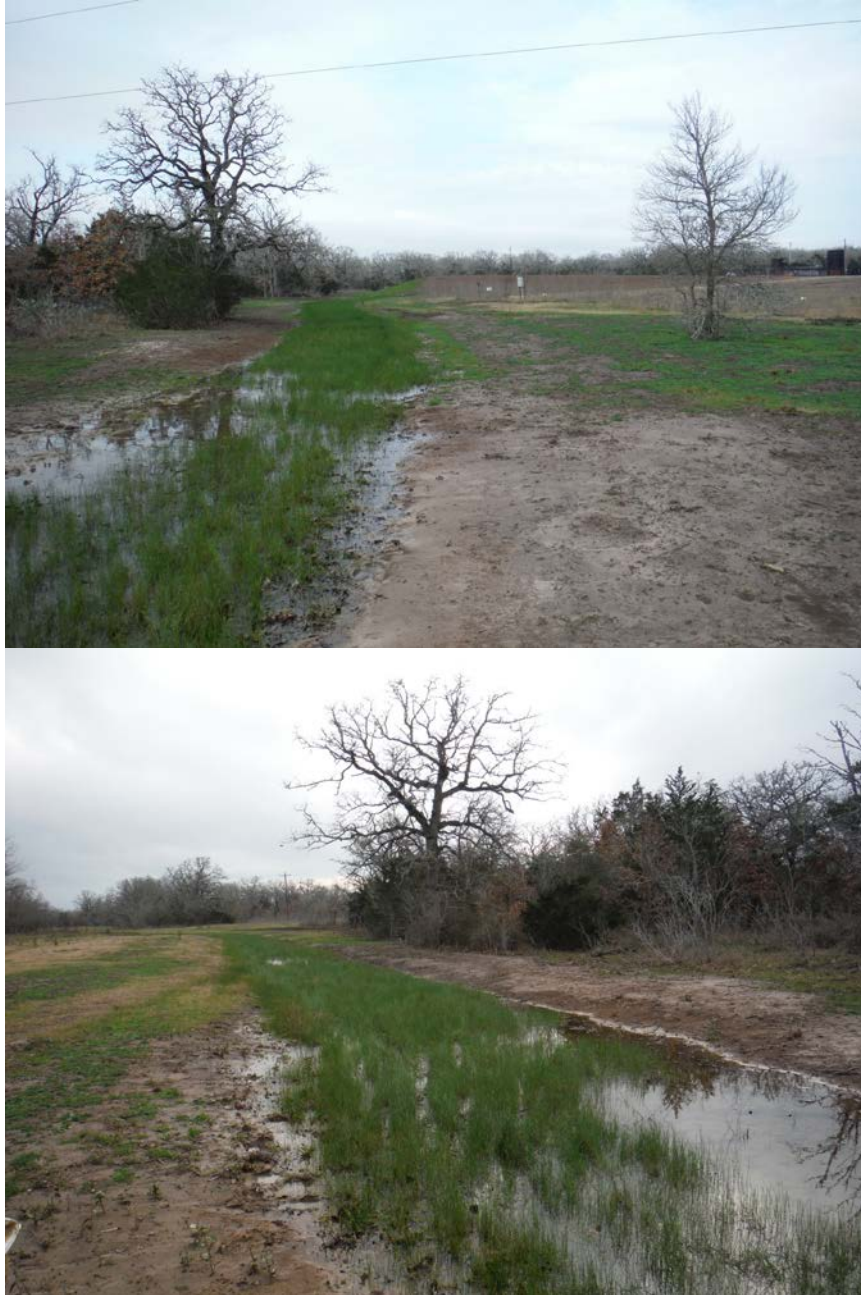
The discharge channel is a constructed, open, earthen discharge channel about 12 feet wide and about 500 yards long. Water depth on March 5, 2014, was generally less than 6 inches in the channel and did not exceed a foot (Figure 4). The channel has extensive growths of spike rush and filamentous green algae. Water was clear throughout the length of the discharge channel. About 500 yards downstream of the holding tank, the channel discharges into a natural stream bed which becomes West Brook Creek. There was evidence of cattle having crossed the discharge channel.

Figure 4. Southwest Muldoon Field Battery 1 discharge channel on March 5, 2014 at 16:50 CST.

Top photo shows the view towards the holding tank from a point about 100 yards downstream of the holding tank.

Bottom photo illustrates the view from the same point towards West Brook Creek. Photos by Catherine Shellman.

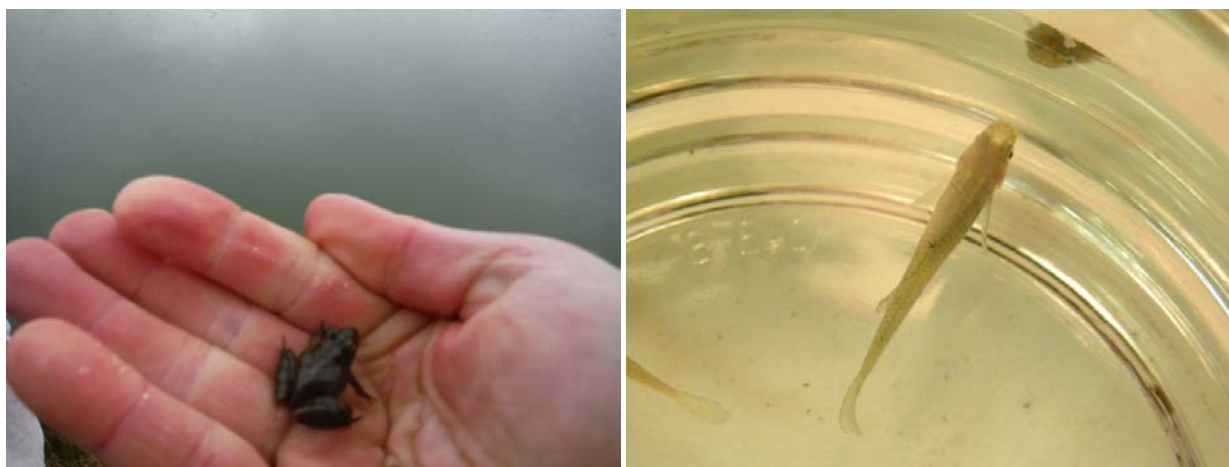
Figure 5. Cricket frog (on left) and Mosquitofish (on right). Photos by Catherine Shellman.

Invertebrates observed in the discharge channel kick net samples included dragonfly and damselfly nymphs, midge larvae, snails (*Physella*), and diving beetles. Vertebrates observed in the discharge channel included Western Mosquitofish (*Gambusia affinis*) and cricket frogs (*Acris*) (Figure 5).

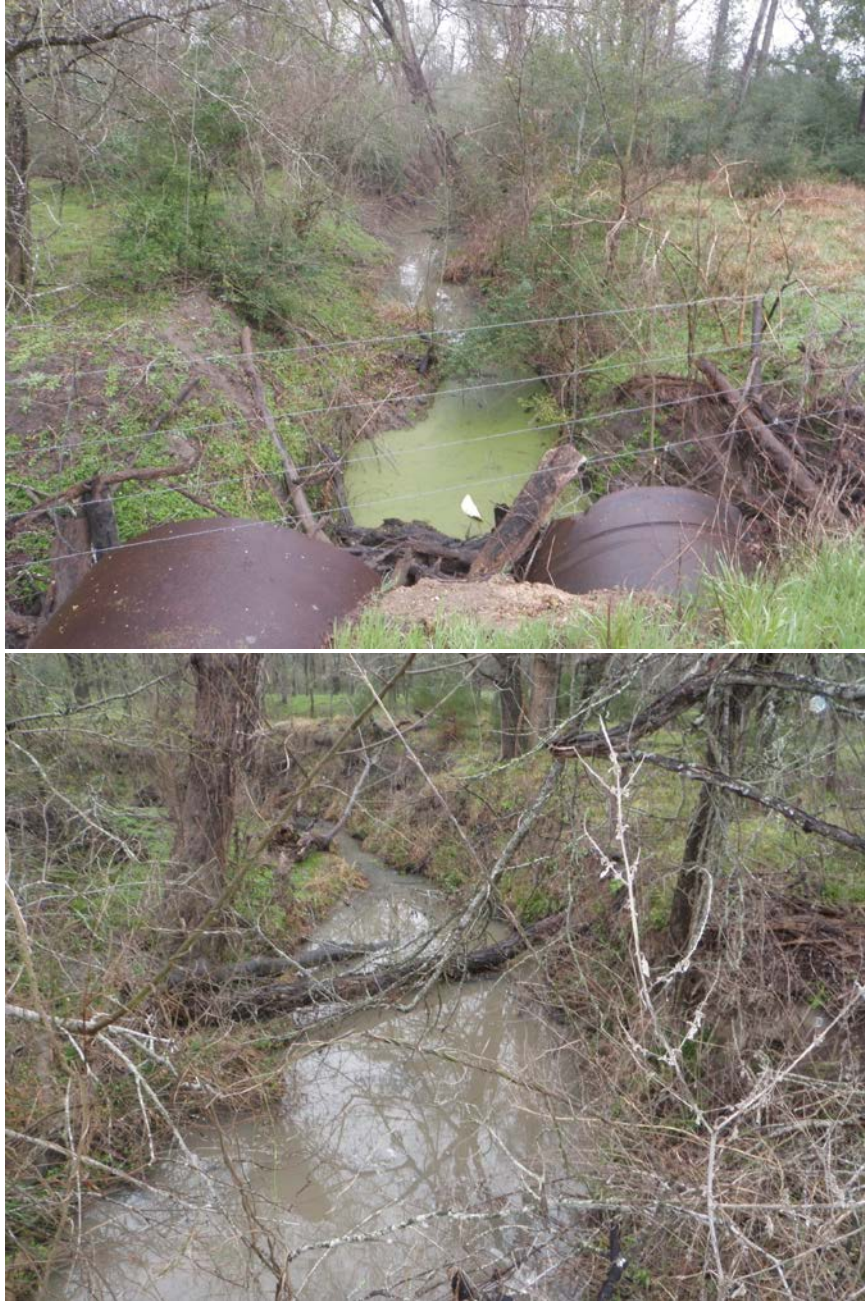
West Brook Creek was sampled at Pavlica Road, 3.5 stream miles downstream of the end of the discharge channel (Figure 6). The creek is narrow, generally less than 6 feet wide, shallow (less than 1.5 feet deep), and dominated by small runs, glides, and pools. One gravel and cobble riffle was present downstream of the bridge. Estimated flow in the creek was 0.3 cubic foot per second. Duckweed (*Lemna*) covered part of the creek. This was the only location at which duckweed was observed. Rooted macrophytes were present.

Figure 6. West Brook Creek at Pavlica Road on March 5, 2014 at 08:30 CST.

Top photo is view towards upstream from bridge.

Bottom photo is view towards downstream from bridge.

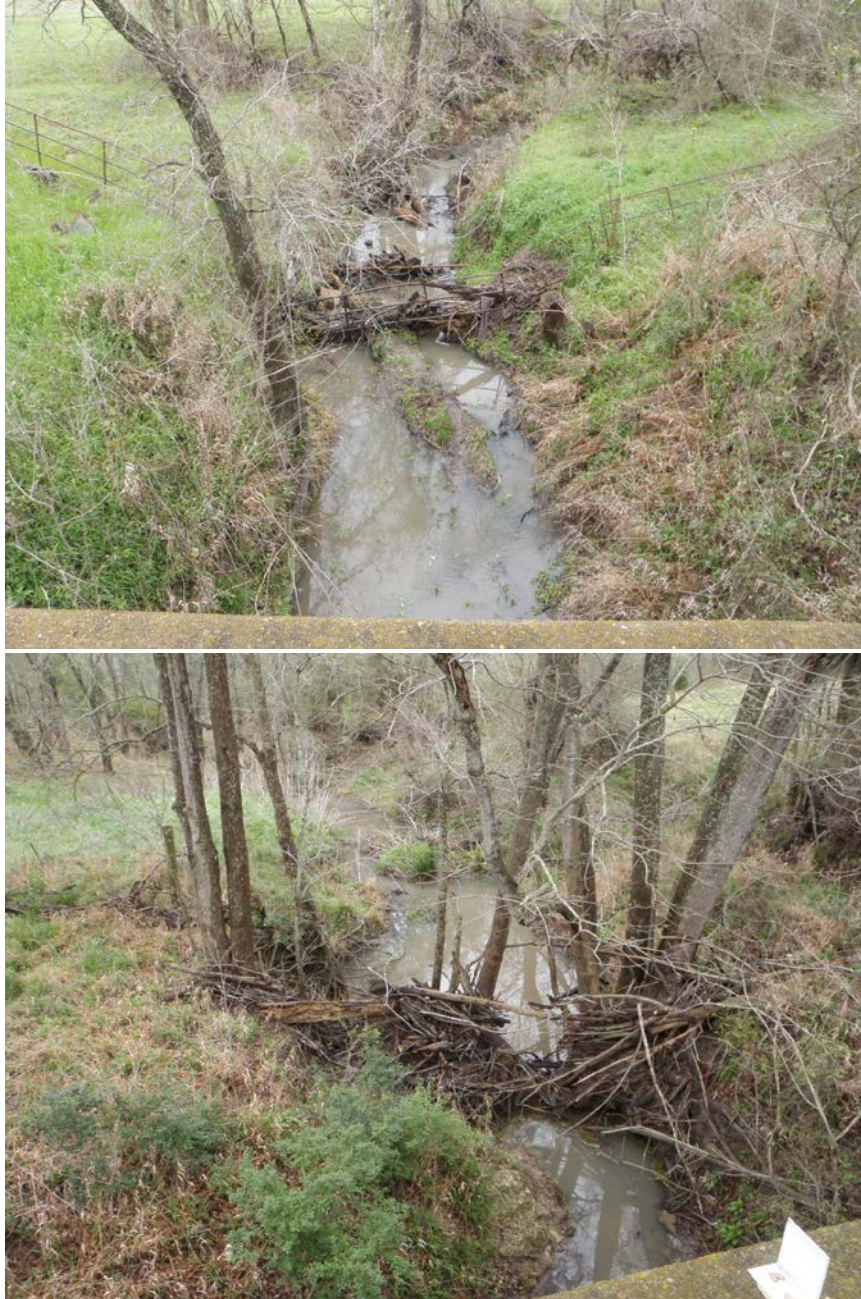
West Brook Creek was also sampled at FM 2762, about 4 stream miles downstream of the Southwest Muldoon Field Battery 1 discharge channel and about 0.5 stream mile downstream of the Pavlica Road crossing (Figure 8). Creek water quality, habitat, and estimated flow were similar to the creek at Pavlica Road. There were signs of livestock next to the creek.

Figure 8. West Brook Creek at FM 2762 on March 5, 2014 at 10:30 CST.  
Top photo is view towards upstream from bridge.  
Bottom photo is view towards downstream from bridge.  
Photos by David Buzan.

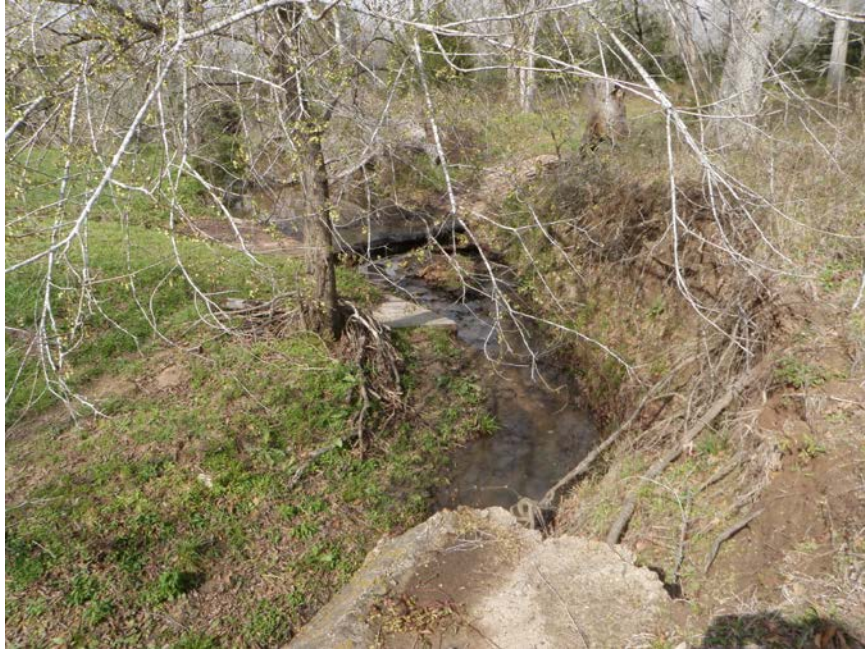
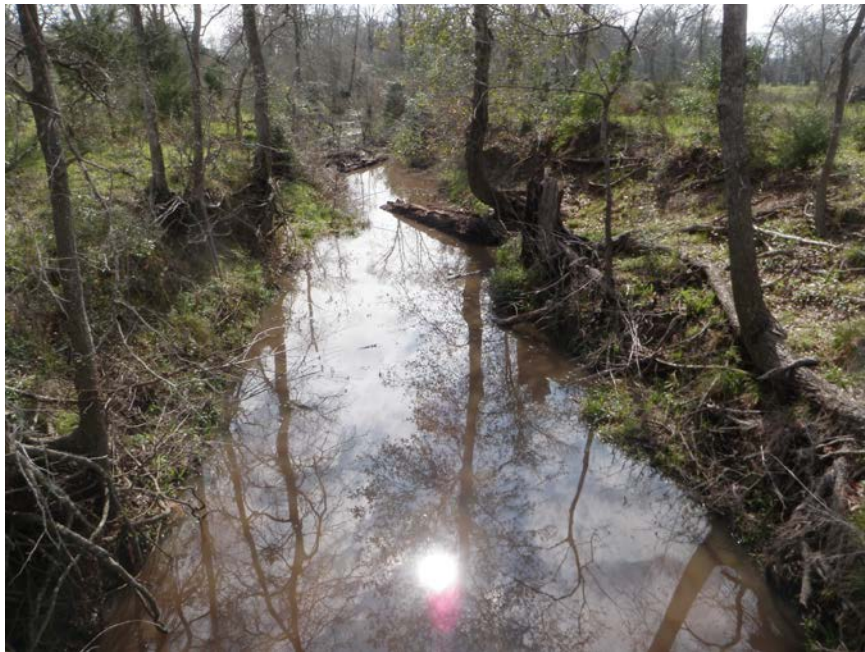
Little 5 Mile Creek was sampled at Two Bit Ranch (Figure 10) at Devine Road just east of Armstrong Derry Road. Creek habitat was similar to West Brook Creek. Estimated flow was 0.3 cubic foot per second. Water primrose was observed at this location. Specific conductance was higher and dissolved oxygen was lower in Little 5 Mile Creek than in West Brook Creek. Cattle tracks crossed the creek in at least two different locations.

Figure 10. Little 5 Mile Creek at Two Bit Ranch on March 5, 2014 at 14:00 CST.  
Photos by David Buzan.

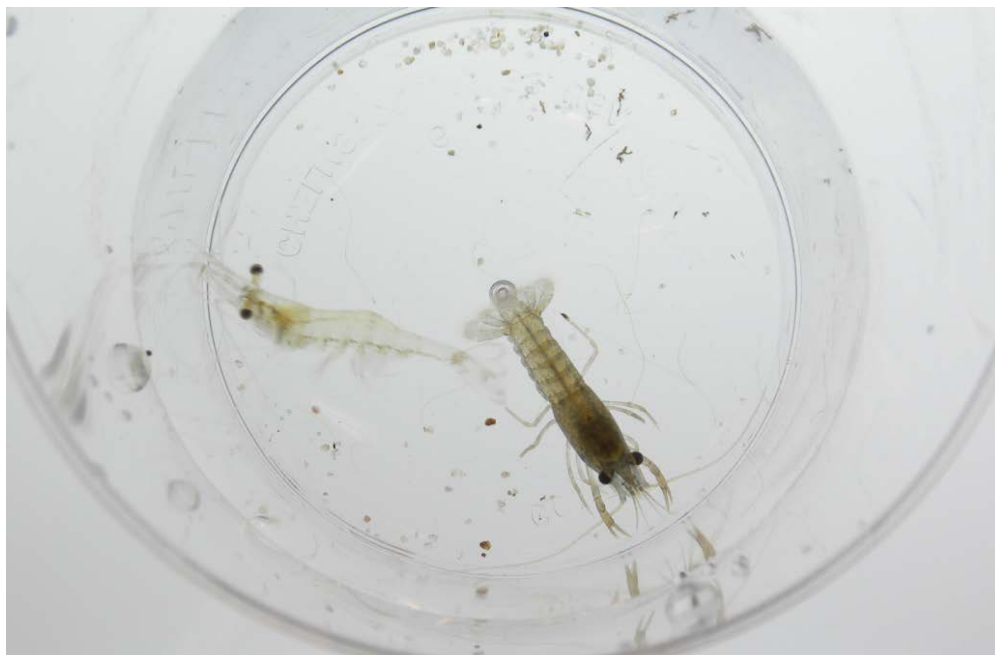
Figure 11. Grass shrimp and crayfish representative of specimens collected from Little 5 Mile Creek. Photo by Catherine Shellman.

Organisms collected in the net plankton and kick net sweeps included (Figure 11):
